CUSTOMER NAME :	Ibstock Brick
CONTACT DETAILS :	Cassey Beamish Casey.beamish@ibstock.co.uk
SITE ADDRESS :	GMI; Circle Square, Manchester
REFERENCE :	BUK418987
SITE SURVEY :	Arch 02
SITE VISIT :	26/11/24
MORE INFO :	enquiries@remedialrepair.co.uk (t) 0800 832 1935

ARCH 02

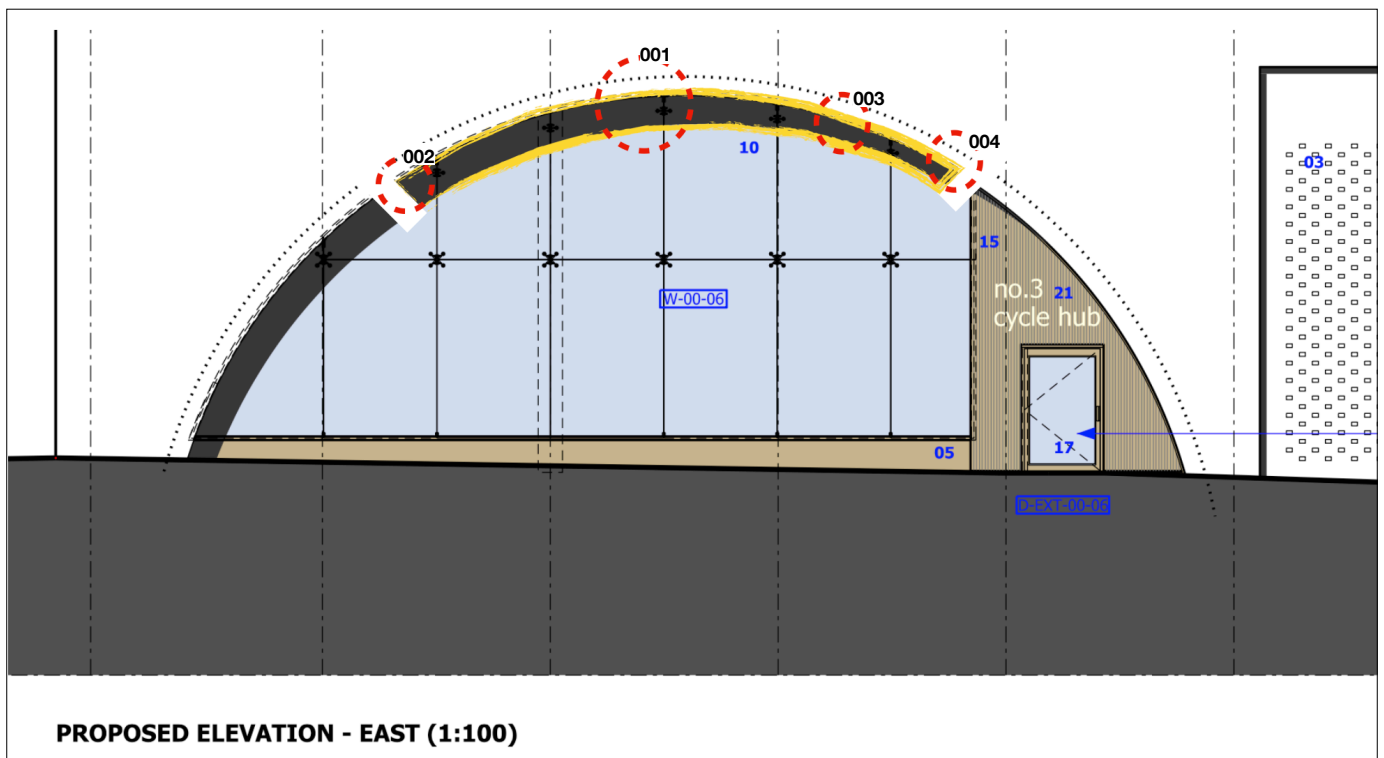
Remove of cracked/damaged brick slips for replacement revealed areas of missing concrete and exposed rebar.

This is so far exposed to four areas as illustrated below, 001/002/003/004.

These areas are all on the middle section of the external arch.

Further areas of brick slips to be removed across this section in order to provide a full inspection and survey (27/11).

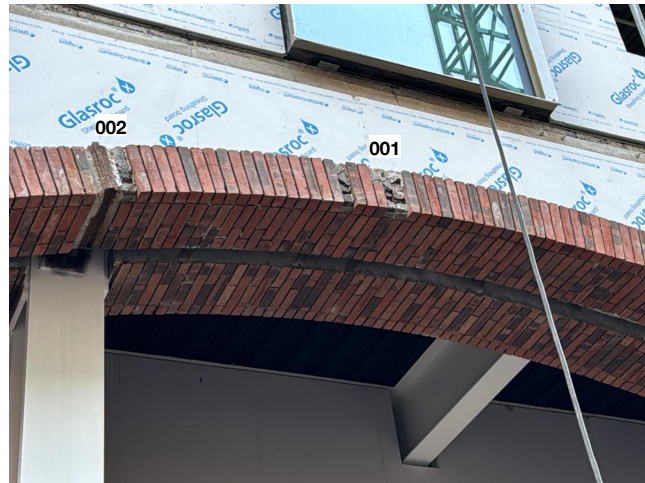
01

Middle section external arch 02.
Two areas of removed brick slips showing two areas (001/002) of missing concrete/exposed rebar.

Further investigation and survey to take place on 27/11 across the middle external section of arch 02 which will include removal of brick slips to gain access and survey.

Removal of slips will be kept to the minimum required in order to carry out the survey, although this could be substantial if the apparent problem continues across this section.

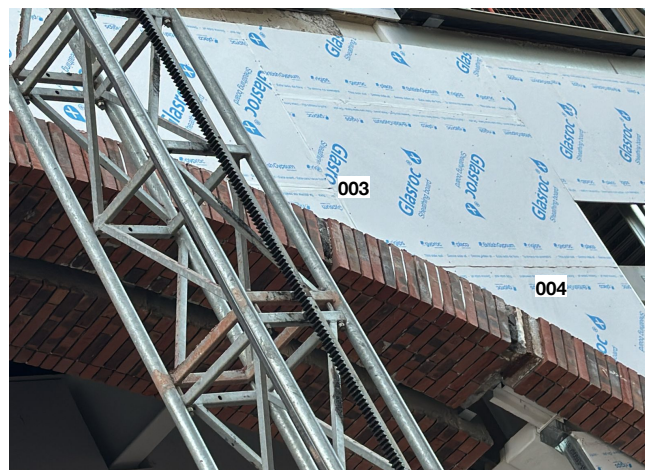
02

Middle section external arch 02.
Two areas of removed brick slips showing two areas (003/004) of missing concrete/exposed rebar.

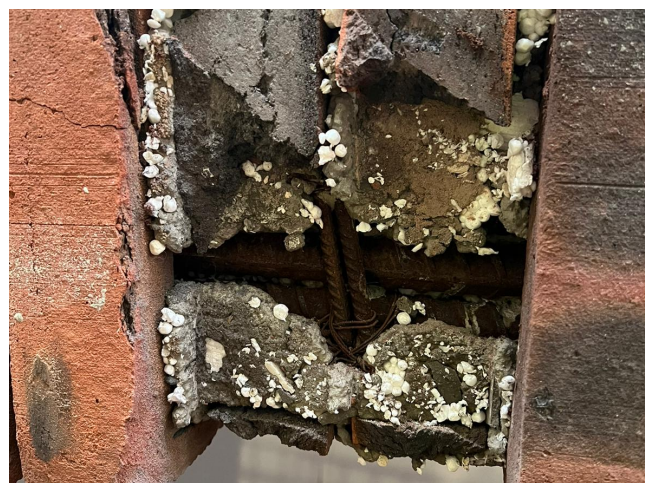
03

Close up of section 001.
Showing missing concrete and exposed rebar.
Large cavity area surrounding rebar with no evidence of any prior fill.
